Quality Steel Corporation Tank

Epoxy polyester urethane liquid coating

Overall Rating: 7.3

Research was provided by KTA-Tator Inc. under PERC Docket 12469, *Testing and Evaluation of Underground Propane Tank Coatings.* The information provided in this document is intended only as a summary of the tank coating performance results; for more detailed findings, please reference the full report.

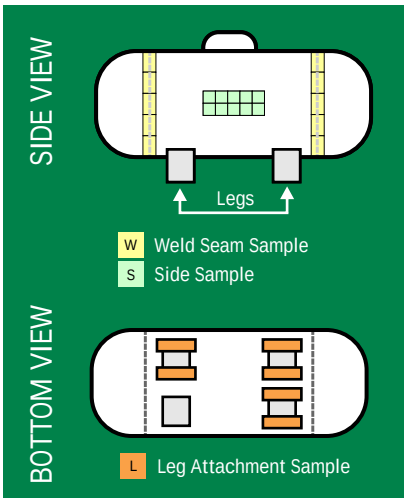
Thermal Cycling—30 24-hour cycles

Nitric acid weld seam
Rusting: ●O
Blistering: 3 ▲O

Sodium chloride side wall
Rusting: rust creep H^{V}

Distilled water side wall
Rusting: ●H

Sodium hydroxide weld seam
Rusting: ●O
Blistering: ●O

Sodium hydroxide side wall
Rusting: ▲H^{I}

Sodium bicarbonate weld seam
Rusting: ●H

Sodium bicarbonate side wall
Blistering: 1 ▲H^{I}–■H^{I}
